# SAFETY BULLETIN

Communication #: I-19-02-A/B/C

## SUBJECT: INDIAN MOTORCYCLE - FORWARD LIGHTING

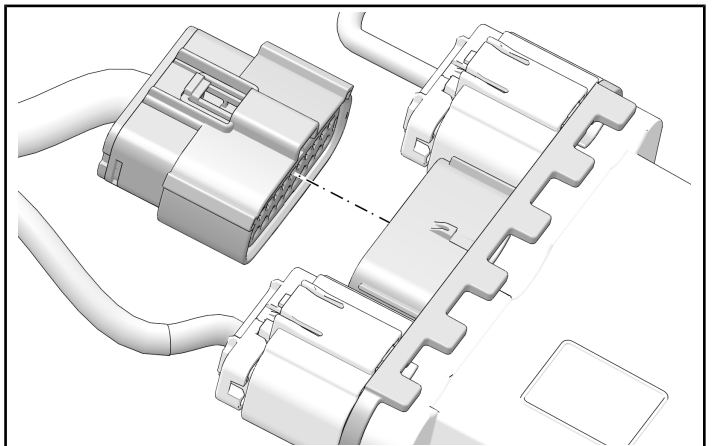
2. Disconnect the center connector on the VCM. Locate Pin 11 of the VCM1 (center) connector and check for any discoloration.

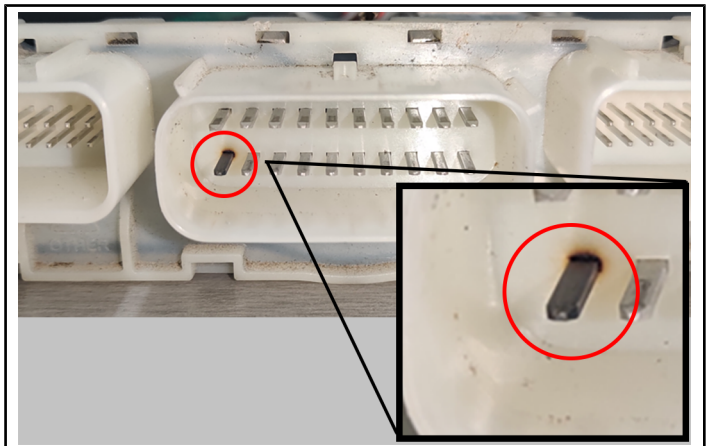
Inspect the male pin on the VCM board for damage.

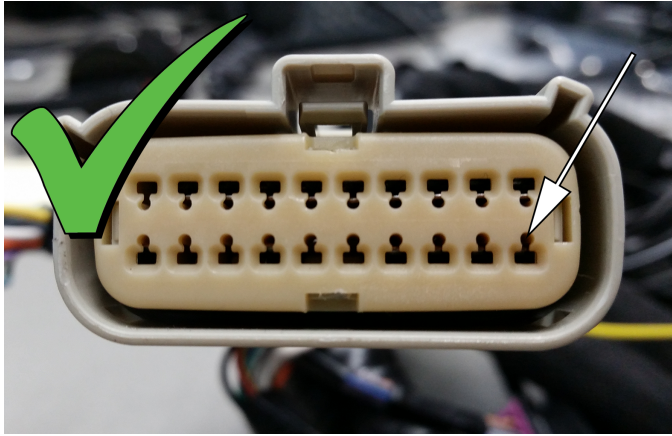
VCM connector, pin 11

**DAMAGE IS NOT PRESENT**

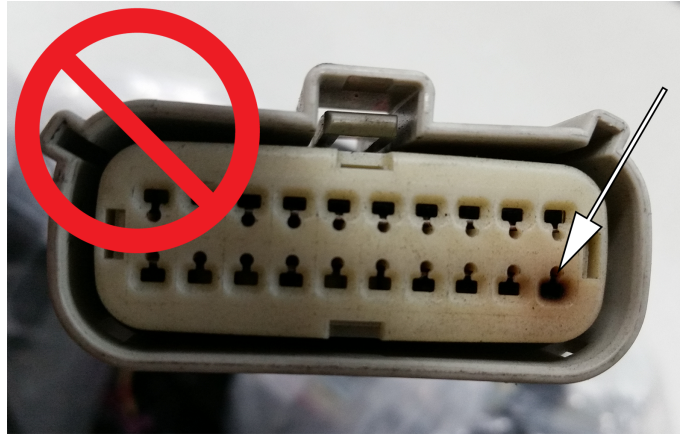
VCM connector, pin 11

Pay special attention to the white terminal lock plate during inspection. If damage is present, a dark halo will be present around pin 11 of the VCM connector. Refer to the pictures below for examples.

**DAMAGE IS PRESENT**

Damage = Any sign of heat damage in or around pin 11 of the center VCM connector (e.g. the dark halo shown in the right image above).

- If damage **IS** present, take pictures of the damage and proceed to I-19-02-B.  
US/CAN: Submit an Ask Polaris Service & Warranty Question> All Vehicle Diagnostic case.  
INT'L: Contact your Country Service Department.
- If damage is **NOT** present, proceed to step 11 to complete I-19-02-A or I-19-02-C.
