# TECHNICAL SERVICE BULLETIN

Bulletin Number: **ATV-08-01A**  
**ATV-08-01B**  
Model Years: **2004.5 / 2005 / 2006**

### SUBJECT: SAFETY RECALL

**Replacement of Electronic Control Modules on Select Model Year 2004.5, 2005 and 2006 Sportsman 500s, Model Year 2005 Scrambler ATVs, Model Year 2005 Sportsman 400s, Model Year 2005 and 2006 Scrambler 500 4x4s, 2006 Sportsman 450s, 2005 Sportsman 600s, 2005 and 2006 Sportsman 6x6s, Carbureted 2005 and 2006 Sportsman 700s, and Carbureted 2005 Sportsman MV7.**

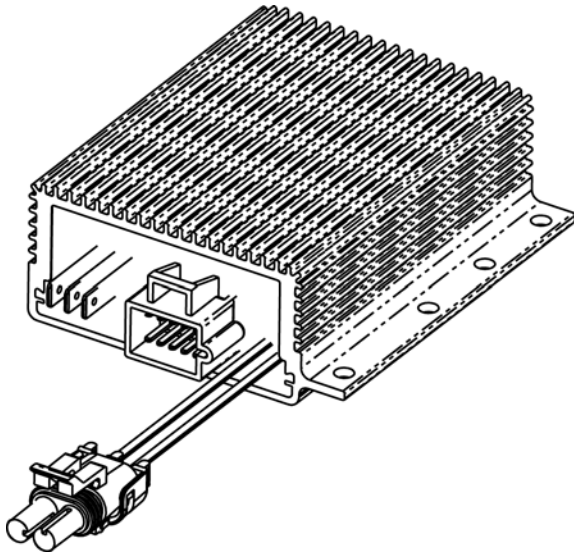
### Potted ECM

PN 401110  
 PN 4011044  
 PN 2203117  
 PN 2203118

Affected models using ECM 4011044 will use ECM Replacement Kit PN 2203350.

Affected models using ECM 4011110 will use ECM Replacement Kit PN 2203348.

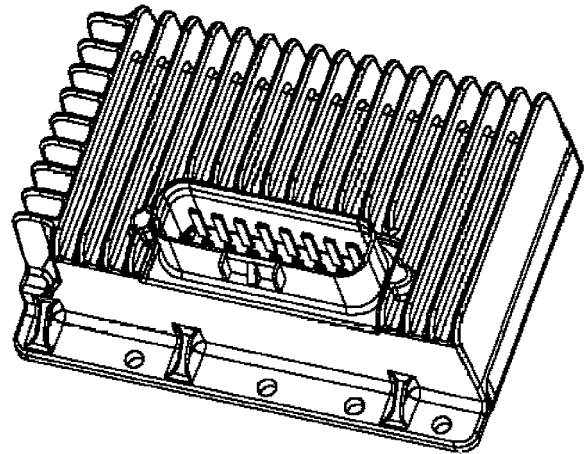
### Unpotted Die-Cast ECM

PN 2203348  
 PN 2203350

**NOTE: Affected units that have already had an unpotted Die-Cast ECM previously installed (see images on next page) are not affected by this current Safety Bulletin. No further action is required on these units.**

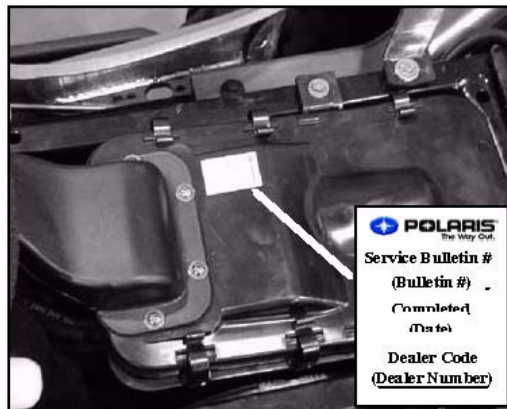
A Service Bulletin Completion Decal must be completed for this bulletin repair. Place the decal on the unit as shown. If you require more decals, order them through normal Polaris parts ordering channels.

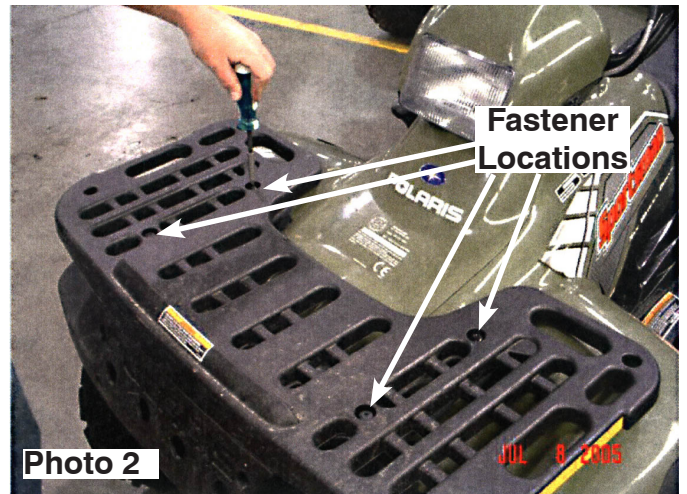
1. To gain access to the Power Distribution Module (PDM), remove the front rack. With the engine turned off, remove the front rack by using the #27 Torx tool to remove the four screws that secure the front rack, in the locations seen **Photo 2**.

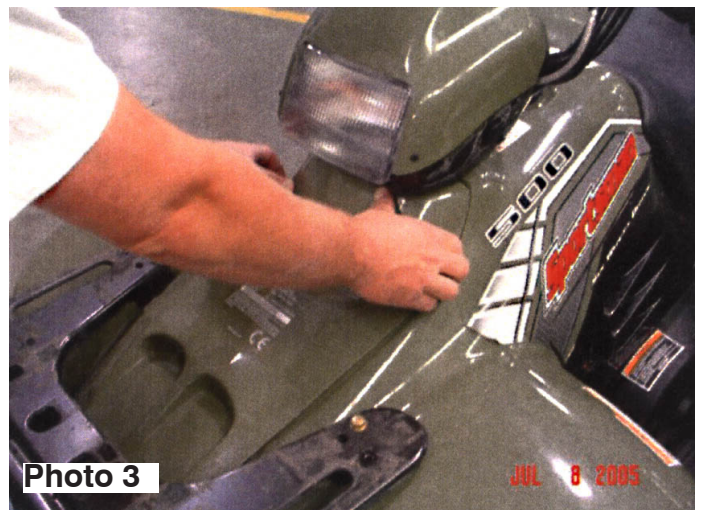
2. Remove the front cover panel as pictured. Loosen the top first, then reach under the front bumper and push on the front securing tab to release the panel. Flex the top of the panel as needed to slide under headlight pod.

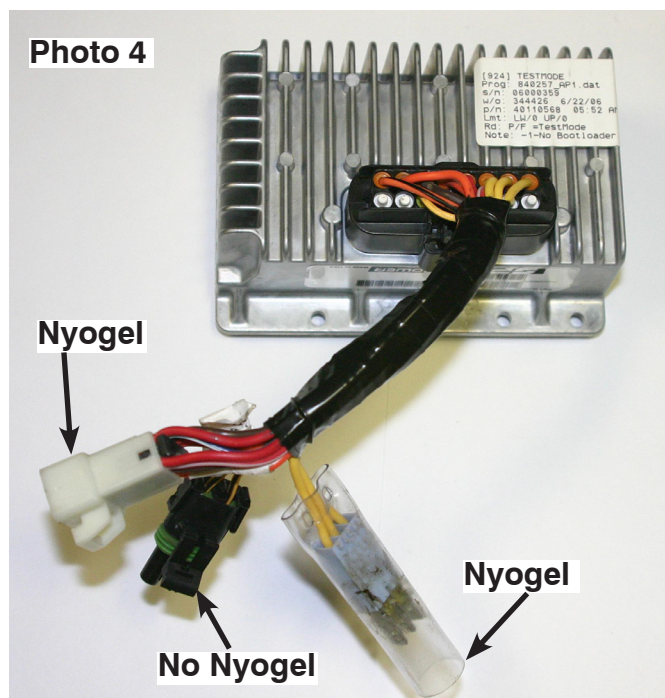
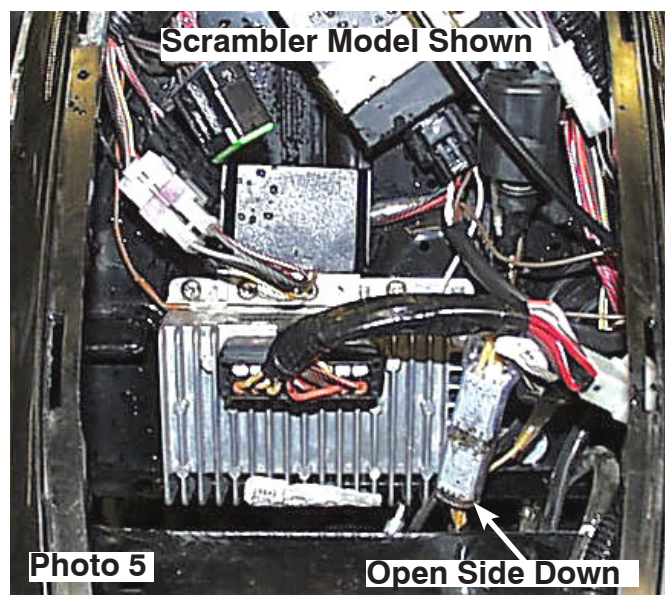
7. With the Dielectric grease tube included in the kit fill the two non sealed connectors of the Jumper harness as shown in **Photo 4**. **IMPORTANT:** DO NOT use Dielectric Grease on the sealed connectors
8. Plug the Jumper Harness into the PDM and the vehicle harness. **Note:** Be sure to position the shielded connector with the open side down as shown in **Photo 5**.
9. Reinstall the front panel and rack/front box assembly.

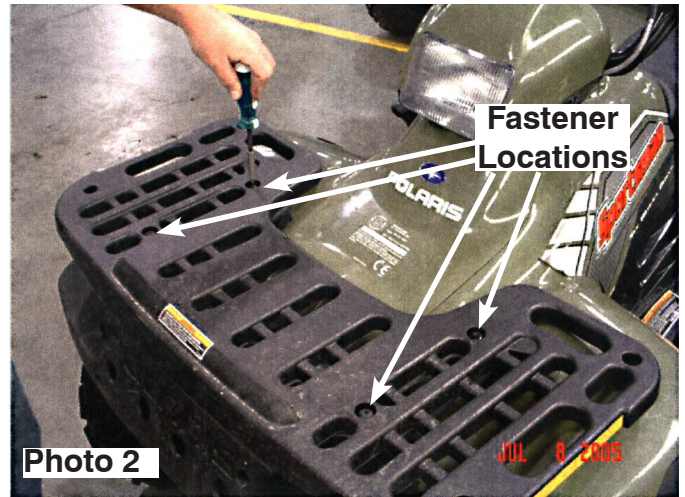
1. To gain access to the Power Distribution Module (PDM), the front rack must be removed. With the engine turned off, use a #27 Torx tool to remove the four screws that secure the front rack, in the locations seen **Photo 2**.

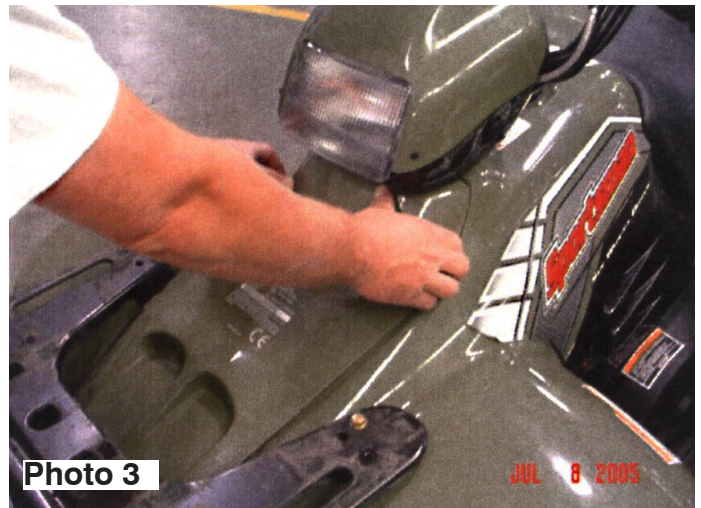
2. Remove the front cover panel as pictured. Loosen the top first, then reach under the front bumper and push on the front securing tab to release the panel. Flex the top of the panel as needed to slide under headlight pod.

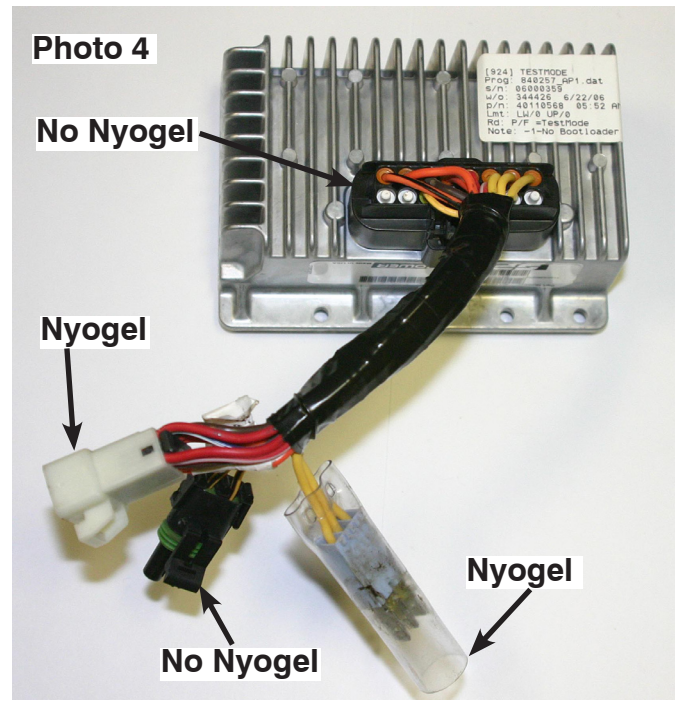
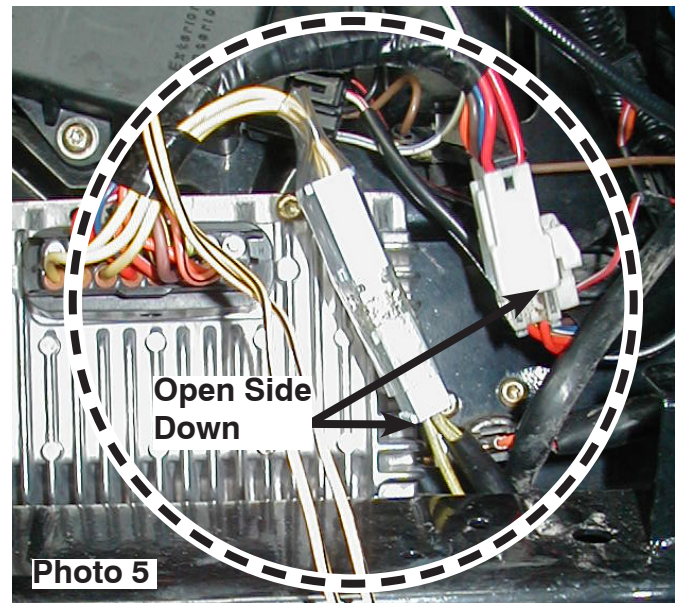
7. With the Dielectric grease tube included in the kit, fill the two non sealed connectors of the Jumper harness as indicated by the arrows in Photo 4.

8. Plug the Jumper Harness into the PDM and then connect to the vehicle harness. **NOTE:** Be sure to position the two non sealed connectors with the open side down as shown in Photo 5.

**IMPORTANT: Connectors must be positioned in direction as shown in Photo 5 with the open ends of the connectors facing down to allow any water that maybe trapped to drain from connector.**
