SAFETY RECALL

RZR

Communication #: Z-22-01

SUBJECT: BATTERY CABLE ROUTING

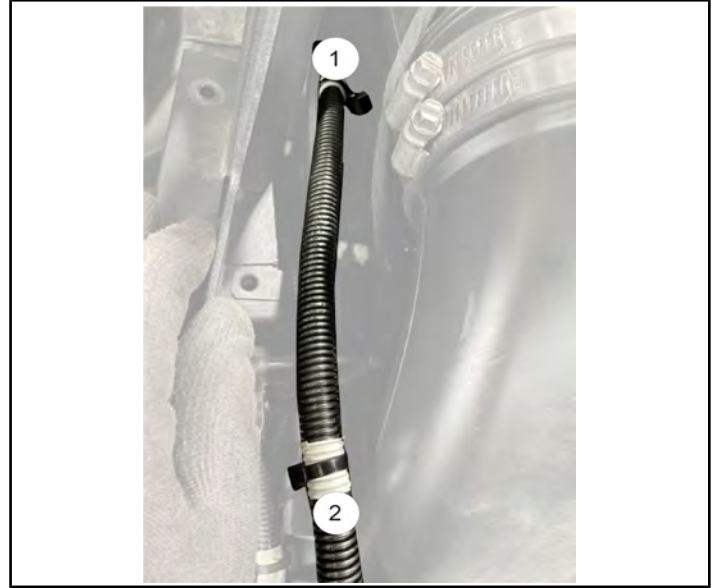
4. Working from the drivers rear seat area, pull the free end of the auxiliary battery positive cable until the area between the two tape marks ① and ② is visible.

5. Inspect the auxiliary battery positive cable between cable routing clip ① and ②. Check for any rub through or damage to the auxiliary battery positive cable.

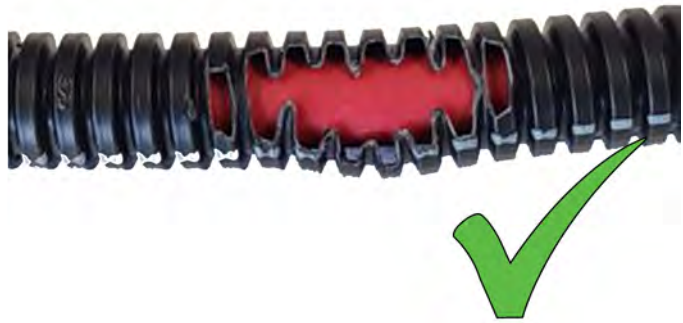
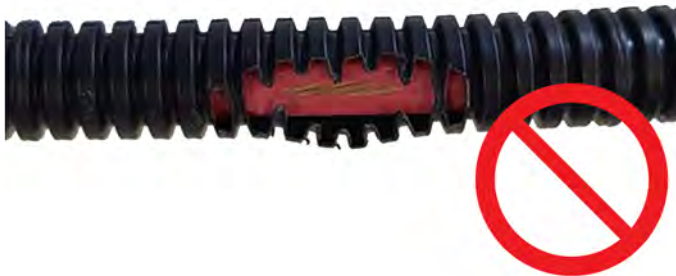
INSPECTION PASS	INSPECTION FAIL

- **PASS:** if the auxiliary battery positive cable has no damage **OR** only the conduit has damage, this cable passes inspection and needs to be re-routed. Proceed to **Auxiliary Battery Positive Cable Re-routing**.
- **FAIL:** If the auxiliary battery positive cable has damage to the wiring insulation, or the copper wiring within the cable is visible the cable requires replacement. Proceed to **Z-22-01-B - Auxiliary Battery Positive Cable Replacement**

<p style="text-align: center;">IMPORTANT</p> <p>If damage to the conduit ONLY is present, wrap the area in abrasion-resistant electrical tape (Coroplast 837, 3M Scotch 22, or similar). Proceed to Z-22-01-A - Auxiliary Battery Positive Cable Re-routing.</p>	<p style="text-align: center;">STOP!</p> <p>If the auxiliary battery cable fails the inspection, proceed to Z-22-01-B - Auxiliary Battery Positive Cable Replacement.</p>

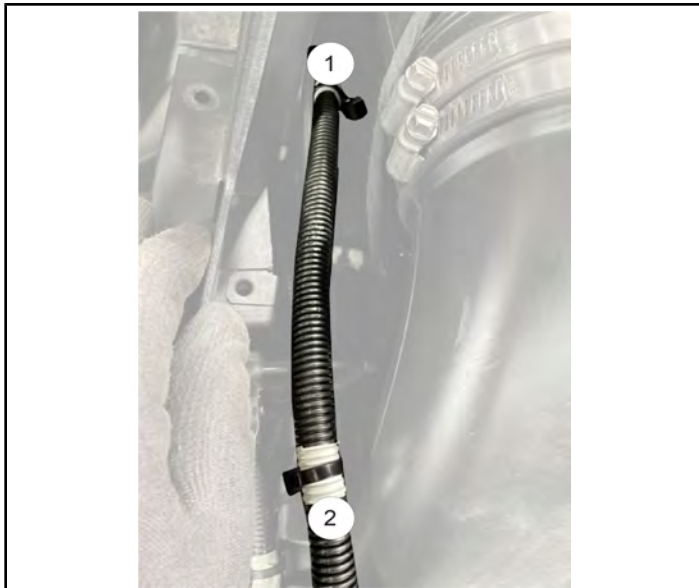
One loop of the cable tie will be installed to the auxiliary battery cable in locations ① and ②. The other side will be installed around the seat base bracket (wishbone brackets).

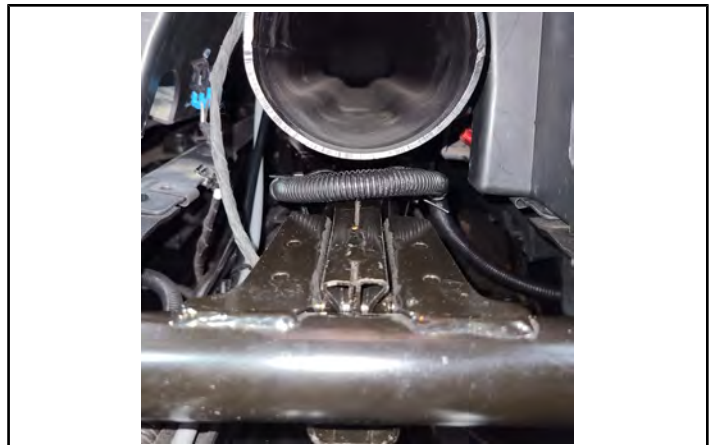
2. Starting from the drivers side route the cable over the seat base bracket (wishbone brackets) and under the PVT duct. Make sure the cable is routed in front of the accessory power port harness.

Image shown with the rear PVT duct removed for clarity. The PVT duct does not require removal to complete the procedure.

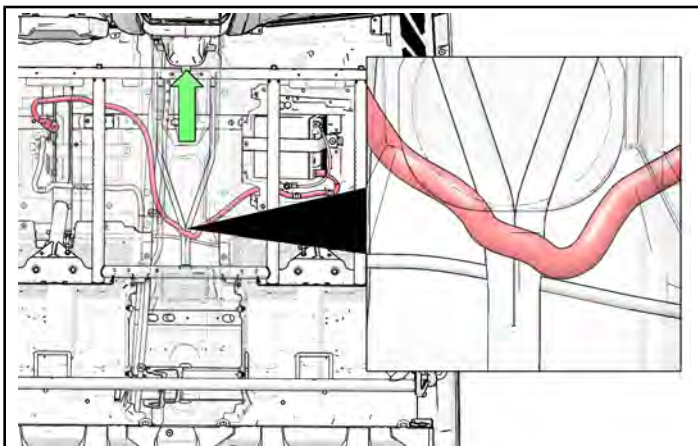
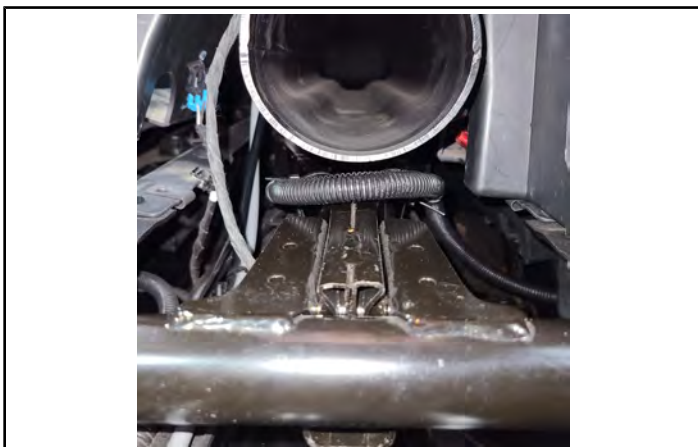
16. Starting from the drivers side route the cable over the seat base bracket (wishbone brackets) and under the PVT duct. Make sure the cable is routed in front of the accessory power port harness.
